SW1500 Low Voltage Rewire on Site in Arkansas

(Originally built as Richmond Fredericksburg and Potomac Railway Engine #1)

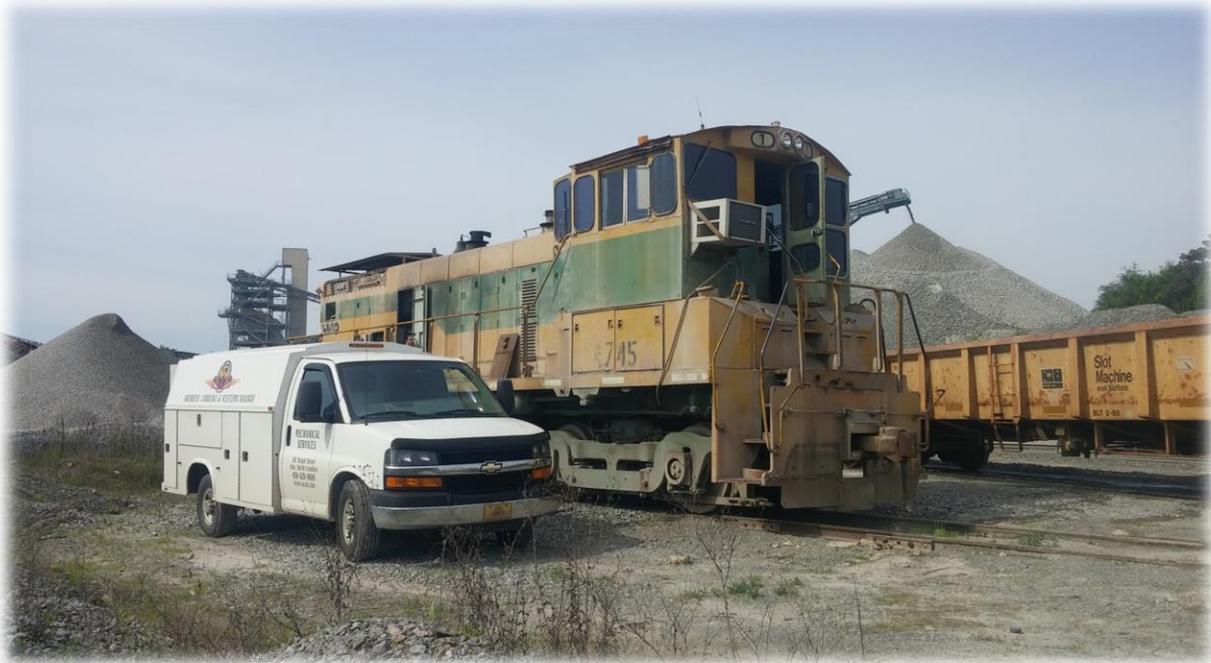
(170)

This locomotive was rewired due to numerous low voltage grounds, deteriorated insulation, and failure to start. Root cause of failure was the deterioration of the main loom (#2 run) from the main terminal boards (50s) to the front terminal boards (80s). The loom had been buried under dust and dirt. This trapped the moisture next to the wires, providing a path to ground as well as from circuit to circuit.

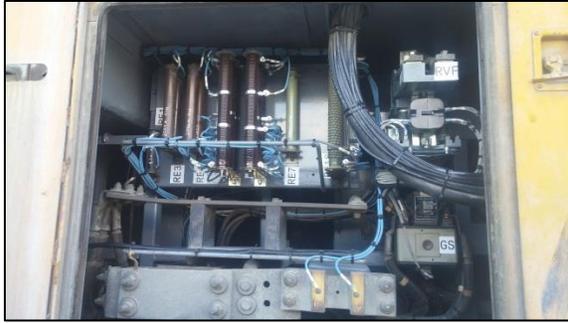
After (281)

The high voltage cabinet was stripped of components, cabinet cleaned and painted. Components were cleaned, qualified, labeled and reapplied. New hardware was used on high voltage connections. Head light resistors were moved from under the walkway step to the resistor panel to improve ease of maintenance. Remote control air lines and electrical harness were not disturbed. Battery charge rectifier (CRBC) was repaired and rotated 180 degrees to allow it to be installed per manufacturer's instruction.

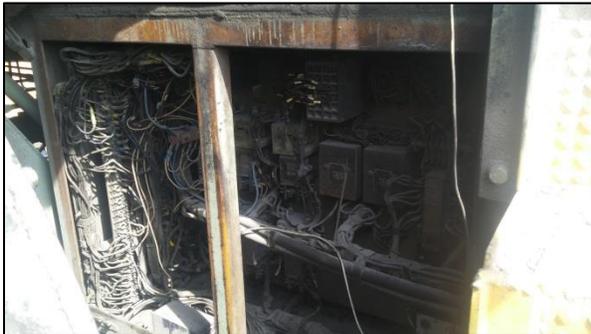
Before (174)

The relay cabinet was stripped of components, cabinet cleaned and painted. Components were cleaned, qualified, labeled and reapplied. New hardware was used on high voltage connections and bolt on terminal boards. Terminal boards 35 and 38 were moved to improve ease of maintenance. Bad order and near fail components were replaced.

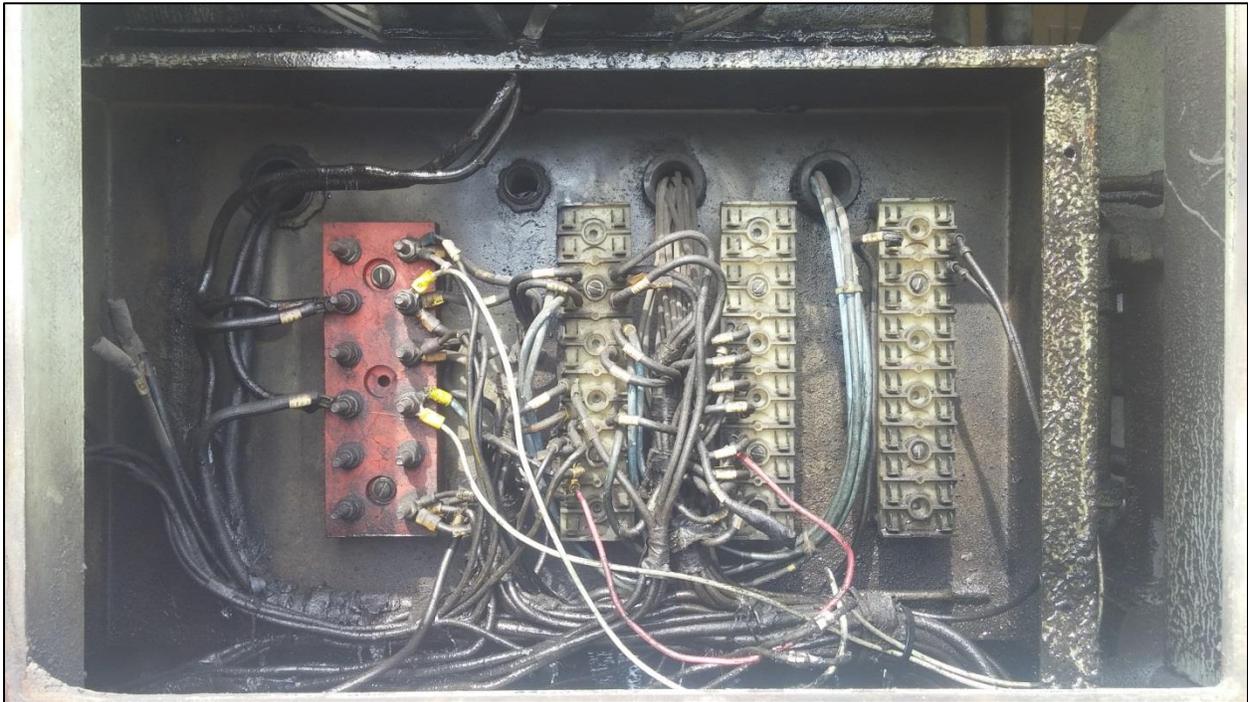
Before (165)

The terminal board cabinet for terminal boards 80 through 83 was stripped of components, cabinet cleaned and painted. Terminal boards were cleaned, qualified, labeled and reapplied. New hardware was used on bolt on terminal board 83. Spare wires were added and terminated to terminal boards.

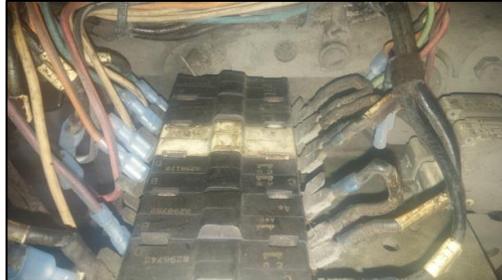
Before (002)

The control stand was stripped of components and cleaned. All light fixtures and switches were replaced with new components. This included all roller switches in the controller. Obsolete switches were removed and other switches were relocated to control stand for ease of access to the engineer.

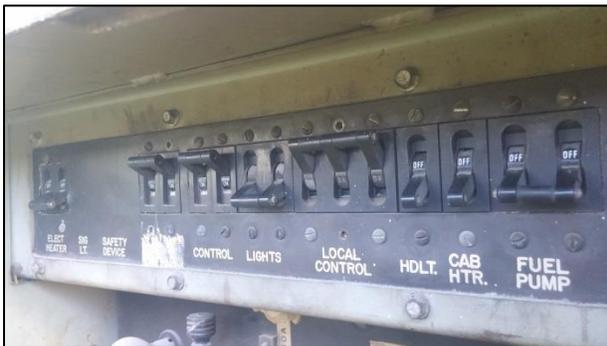
Before (198)

The battery switch compartment was cleaned. All fuses qualified and inspected. Circuit breaker panel was removed, cleaned, painted and labeled. Circuit breakers were replaced with new components. Cab heat circuit breakers had been located in inaccessible locations. All circuit breakers are now located in the circuit breaker panel.
